**INTERIM STORAGE FACILITY
DECOMMISSIONING
FINAL REPORT**

CONTRACT: DE-AT03-82SF11669
ISSUED: 15 MARCH 1985

Decontamination and decommissioning of the Interim Storage Facility were completed. Activities included performing a detailed radiation survey of the facility, removing surface and imbedded contamination, excavating and removing the fuel storage cells, restoring the site to natural conditions, and shipping waste to Hanford, Washington, for burial. The project was accomplished on schedule and 30% under budget with no measurable exposure to decommissioning personnel.

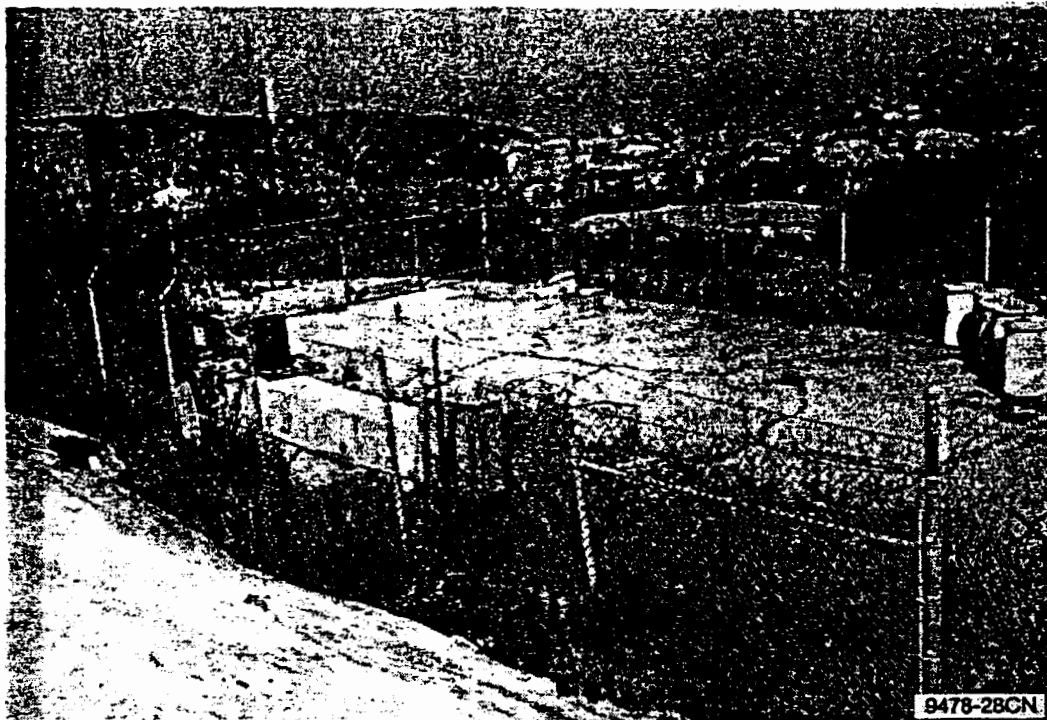
Figure 1. Interim Storage Facility (T654)

The ISF (Figures 1 and 2) was located at Rockwell International's SSFL approximately 35 miles northwest of downtown Los Angeles. The ISF was near

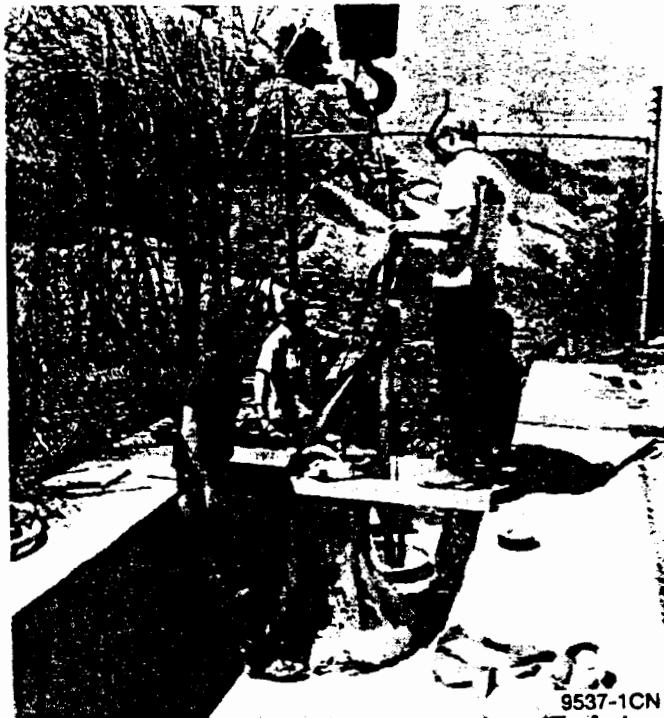
Figure 5. Dummy Fuel Element Basket Removal

Contaminated dummy fuel element baskets were found in five of the storage cells. These were removed using a Grove crane as shown in Figures 5 and 6. Each basket was drawn into a plastic bag as it was removed from its respective storage cell. These packaged baskets were transferred to the Radioactive Materials Disposal Facility (RMDF) for disassembly and disposal.

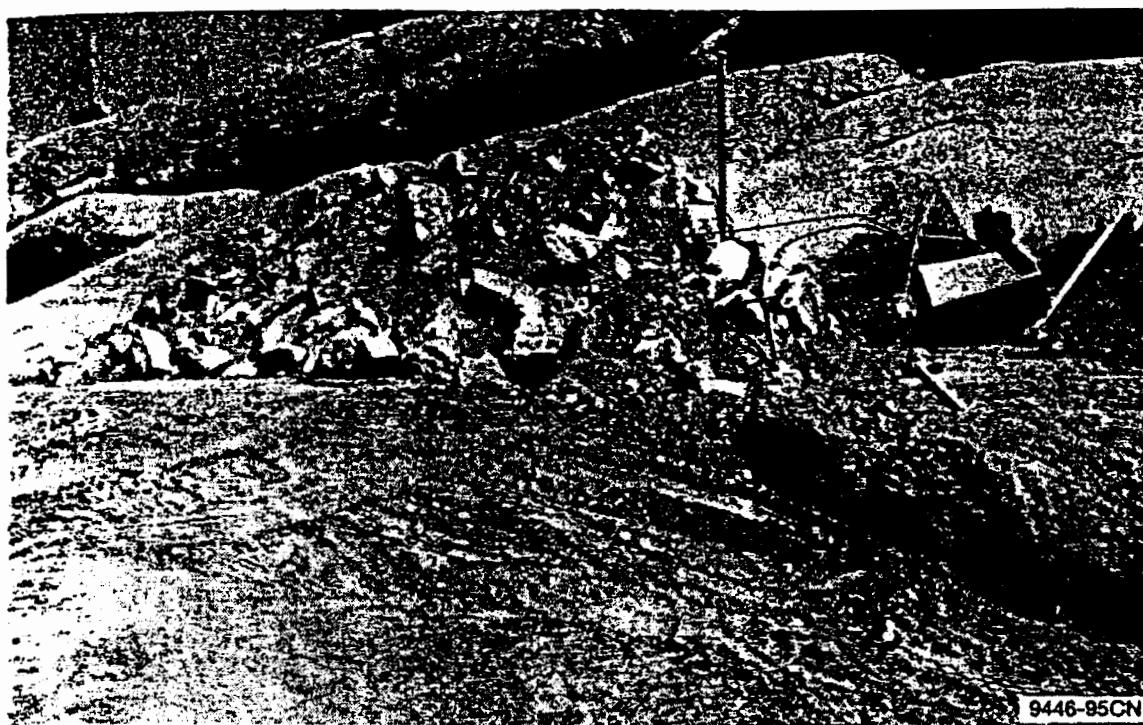
Figure 9. Broken Concrete Retention Area

The first excavation operation required removing the concrete trench that contained the upper portion of the storage tubes. This uncontaminated material was temporarily stored in a retention area (Figure 9), then later used for backfill material.

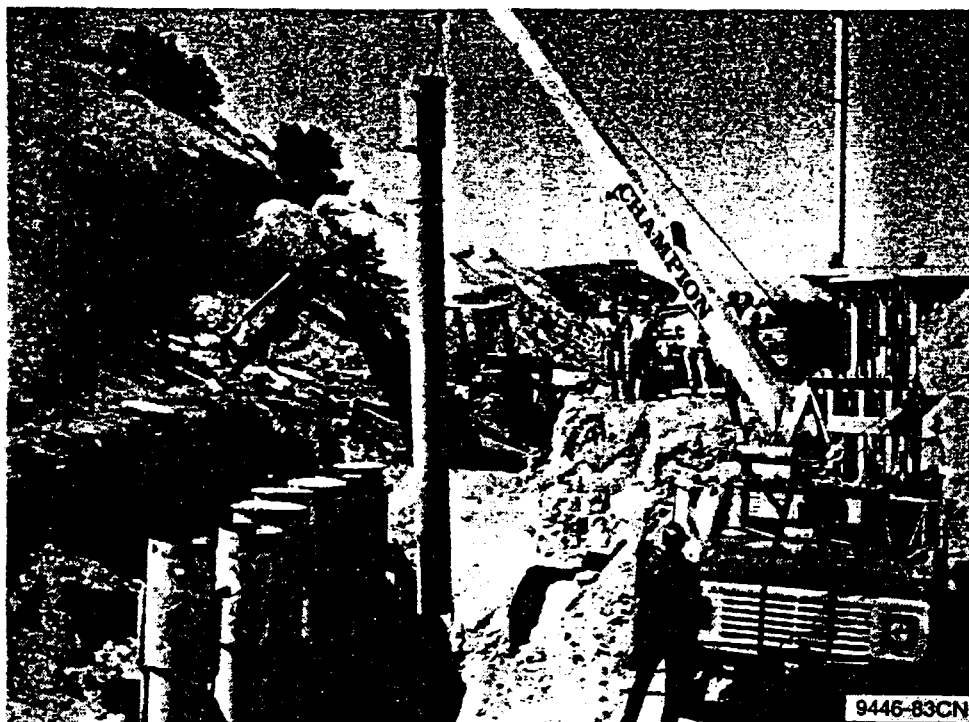
Figure 13. ISF Storage Cell Removal

A mobile crane was used to transfer each storage tube to a flatbed truck for transport to the RMDF (Figures 13 and 14). As each storage tube was removed, it was surveyed (no external contamination was detected), and a plastic bag was placed around the lower section. This secondary precaution was to prevent the spread of contamination during transit. A soil sample was taken from each of the emptied storage tube wells as the tube was removed (Figure 15). These samples were analyzed for ^{60}Co , ^{137}Cs , and other gamma emitters; the results are presented in Section 4.7.

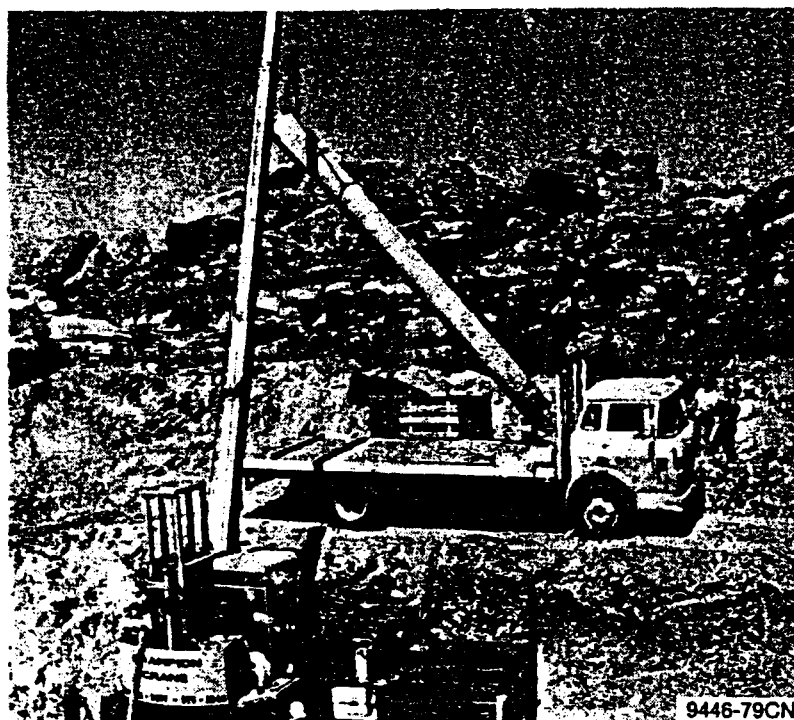
Figure 14. ISF Storage Cell Transfer

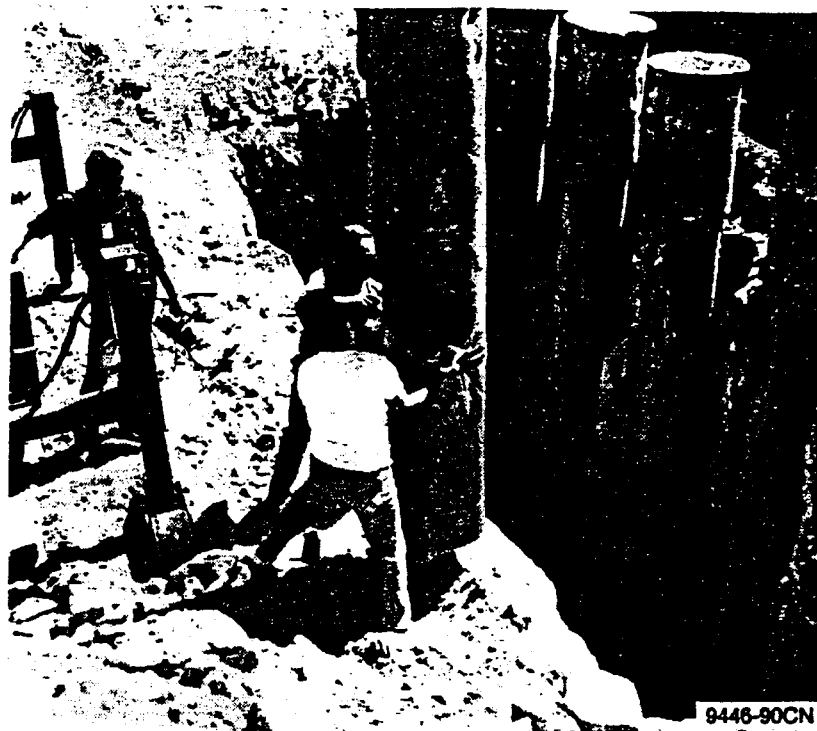
Figure 15. Collecting Dirt Sample at
Bottom of Cell Shaft

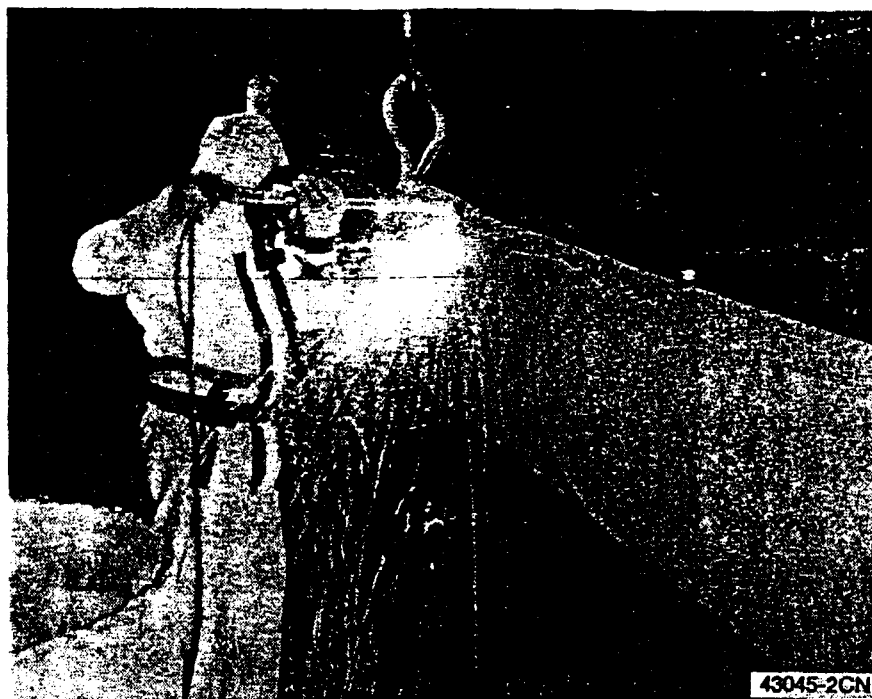
Figure 17. ISF Storage Tube Cutting

The 25-ft-long fuel element baskets and storage cells were transferred to RMDF for size reduction and packaging. Both storage cells and baskets were sectioned into approximately 4-ft lengths using an oxygen acetylene cutting torch in Building 021. Figures 16 and 17 show the cutting operation. A special prefilter smoke retention housing was fabricated to prevent the facility's absolute filters from plugging with the large amount of particulate matter generated during cutting activity.
